# 2025 Reserve Study & Maintenance Plan

## Tomahawk Destiny

Portland, OR

March 19, 2025

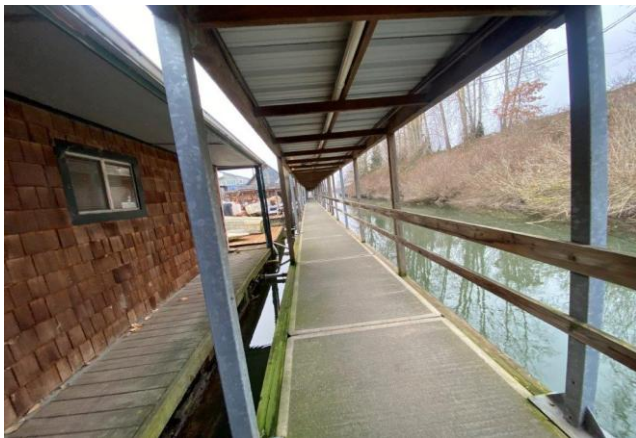
Dock-East-Concrete Safety Repair

**Comments:** This is a budget to repair curbs and inspect all flatwork for tripping hazards of 3/8" or more, grind down or remove and replace selected sections as needed over a 5 year period; list year, work done and cost here.  
 2025: Advised by board to move to 2030 to be completed with Waler replacement.  
 2012: Work completed at a cost of \$5,591.

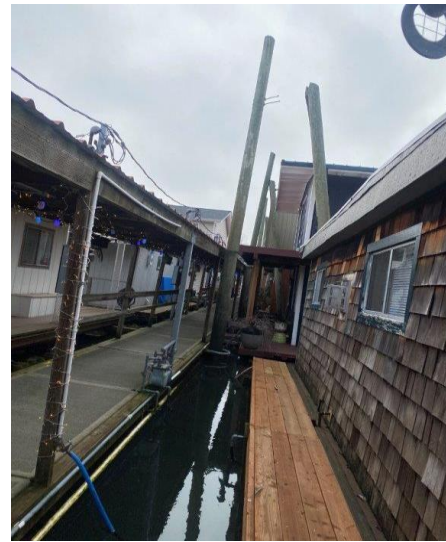
Dock-East-Piling-~Notes

**Comments:** This component serves as a reference section for all East Dock piling replacements, documenting key assumptions, historical records, and planned phasing. The East/West main dock has its own pilings, but because these are structurally tied to the fingers, it is assumed that piling replacements scheduled for each finger will also include pilings adjacent to the perpendicular offshoot where the fingers connect, as well as pilings on the opposite side of the East/West dock. No separate client-provided replacement plan exists for main dock pilings, so it is assumed that these necessary supports are included in the phased replacements.

Piling replacements are being phased over multiple years. Work on Finger 2 is scheduled for 2027, Finger 3 for 2028, and Finger 4 for 2029, with replacements assumed to include both the finger pilings and adjacent structural supports. Finger 1 was partially completed in 2021, with three pilings replaced with steel, while the remaining three pilings are scheduled for replacement in 2030. Future inspections should confirm the exact number of pilings supporting the East/West dock to ensure all are accounted for.

It is also assumed that all future piling replacements will replace existing wood pilings with steel pilings, continuing the transition started in 2021.

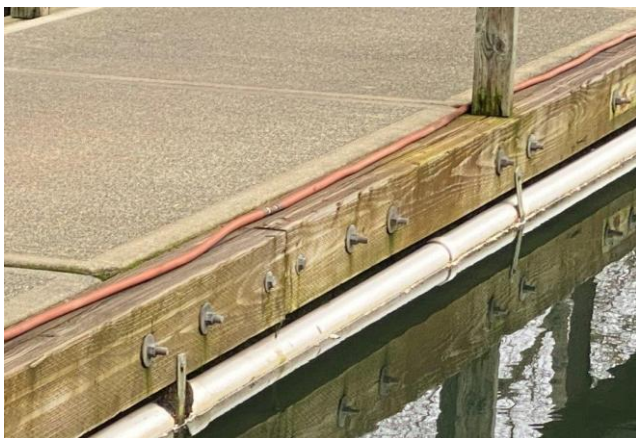
Dock-East-Waler System-Replace	9,640	Sq.Ft.	\$ 11.00	\$ 122,974	2005	25	2030	6	No
<p><b>Comments:</b> The reported last full waler system replacement was completed in 2008; however, for the purpose of aligning future replacement cycles to 2030, the input year has been offset to 2005. The waler system connects the concrete float modules, distributing loads evenly to ensure structural integrity and movement flexibility. The system consists of structural timber walers, secured with through-rods spanning the width of the dock.</p> <p>2025: The client has provided a projected cost of \$100,000 for 2030 2008: Full waler system replacement completed for \$54,083 (\$5.61)</p>

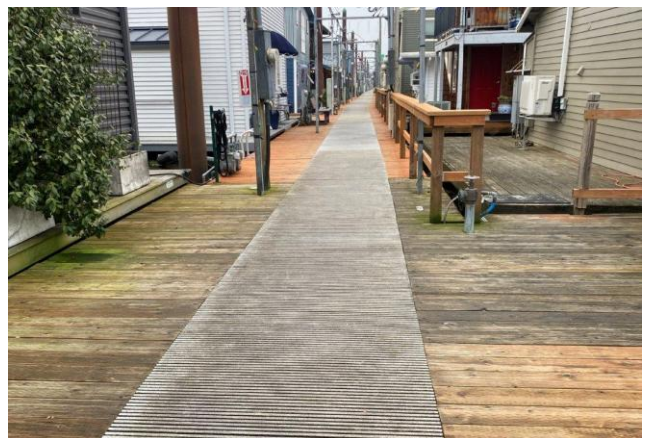
Dock-West-~Notes

**Comments:** This component serves as a reference section for all West Dock-related reserve items, documenting key assumptions, historical context, and planned replacements. The West Dock measures approximately 900 feet in length with eight 60-foot fingers. Unlike the East Dock, there is no canopy, and the walking surface consists of a central 4-foot-wide FRP grating system, flanked by wood decking on either side. The dock underwent structural repairs over a 12-year period, concluding in 2024, which included the replacement of logs, stringers, and decking.

No separate plan exists for pilings along the main East/West dock, but since the pilings supporting the fingers are structurally tied to this section, it is assumed that their replacements will also address the necessary supports for the main dock. Any future piling replacements will continue the transition from wood to steel. The remaining wood pilings are minimally structural, and there is currently no plan for their replacement, though future assessments may determine otherwise.

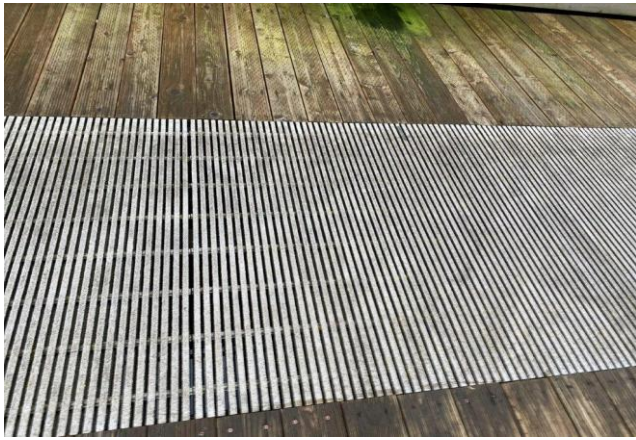
Item Description	# of Items	Unit	Current Item Cost	Future Replacement Cost	Year Built	Useful Life	Year Replace	Life Left	One Time?
Dock-West-Grate-Replace	1	Total	\$ -	\$ -	2025	50	2075	51	Yes
<p><b>Comments:</b> The FRP grating system spans the center of the 900-ft main dock, covering a 4-ft width along the entire length. The original installation was completed in 2013, utilizing 216 grating panels measuring 4'x4' each.</p> <p>2025: Advised by board to removed cost, board intends to pay from the Operating Budget as needed.</p> <p>2013: FRP grating installed along the center of the main dock. 216 panels (4'x4' each) purchased from Robertson Grating for \$225 per panel</p>									
Dock-West-Piling-Remove	14	Each	\$ 1,500.00	\$ 25,586	1971	61	2032	8	Yes
<p><b>Comments:</b> The remaining (14) 12" wood pilings that were originally installed in 1971 and reported to be minimally structural. While no immediate replacement is planned, a 60-year lifespan has been assigned, placing the estimated replacement within the next 30 years. Given their reduced structural importance, future assessments may determine whether full replacement is necessary or if selective reinforcements can be implemented instead. Replacement is scheduled for 2031 as a conservative planning measure.</p> <p>2025: Board advised they intend to remove the remaining wood pilings and requested this work be coordinated with the 2032 dredging project at a cost of ~\$1,500/per piling.</p>

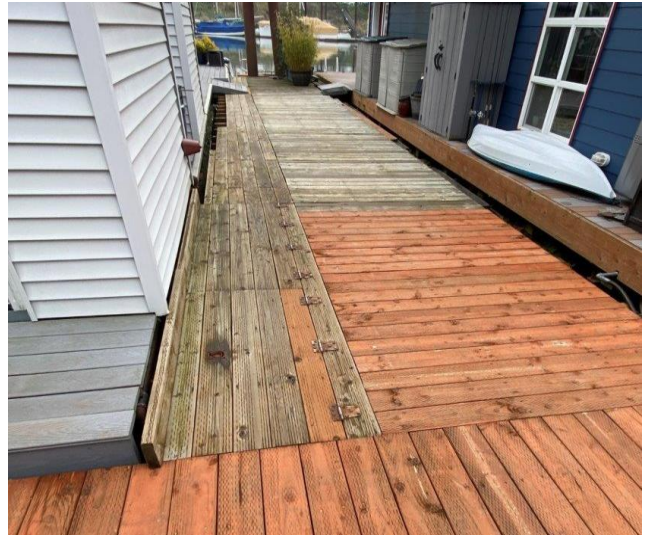
Dock-West-Wood Decking-Replace	8,280	Sq.Ft.	\$ 25.00	\$ 292,486	2018	20	2038	14	No
<p><b>Comments:</b> The wood decking flanks both sides of the FRP grating on the main dock and fully covers the fingers. This decking was fully replaced by 2024 (2012-2024), meaning the next replacement cycle is projected for 2054 based on a 30-year useful life assumption</p>									
Dredging-Execution	1	Total	\$ 450,000.00	\$ 548,281	2022	10	2032	8	No
<p><b>Comments:</b> Dredging involves the removal of accumulated sediment from beneath structures and access areas to maintain navigable water depths and prevent structural loading issues on submerged pilings. The work is performed using hydraulic or mechanical dredging equipment, which excavates and relocates sediment to an approved disposal site.</p> <p>Dredging operations require specialized contractors and regulatory compliance with environmental permits, ensuring that aquatic ecosystems and sediment contamination risks are properly managed. The depth surveys conducted five years post-dredge help determine the next dredging schedule based on actual sediment accumulation rates.</p> <p>The most recent dredging project was completed in 2022 at a cost of \$366,734, with prior dredging occurring in 2012 for \$186,000. The next planned dredging event is scheduled for 2031, with an estimated budget of \$450,000 (2025 dollars) based on historical trends and projected costs.</p>

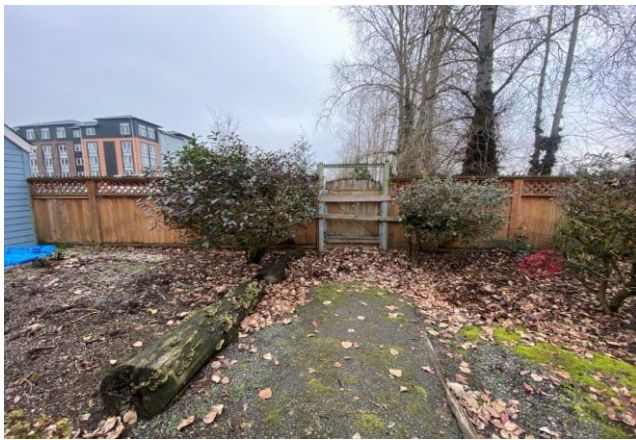
Fence-6' Board w/Lattice Cap-Replace

**Comments:** The current condition and expected lifespan of the 6' board fence with lattice cap are unclear. Previous maintenance history should be reviewed to confirm if the structure requires full replacement or periodic repairs.

2025: Advised by board to add replacement cost of \$35,000 (\$163/lf) board anticipates a replacement year of 2031.

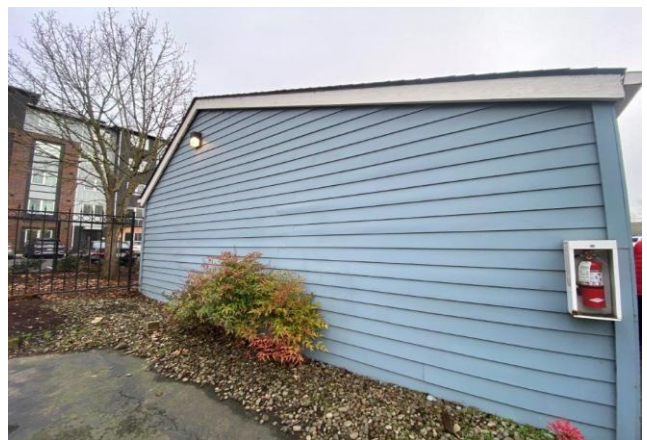
Garage-Paint-Exterior	2	Total	\$ 11,500.00	\$ 31,706	2022	15	2037	13	No
<p><b>Comments:</b> 2 Buildings (25x124) &amp; (25x144) Painted 3 years ago.                      2021: Work completed by King Painting at a cost of \$10,810.                      2005: Work completed by West Coast Finishers at a cost of \$7,263.</p>									
Garage-Siding & Trim-Repair	1	Total	\$ -	\$ -	2025	50	2075	51	Yes
<p><b>Comments:</b> 2 Buildings (25x124) &amp; (25x144)                      2025: Advised to be paid from the Operating Budget.                      2012: Work completed at a cost of \$1,363</p>									
Gate-Entry-Fence-Metal	1	Total	\$ -	\$ -	2024	35	2059	35	Yes
<p><b>Comments:</b> Fence &amp; Metal Gates; useful life greater than or equal to 30 years. Replacement cost not included at this time.                      2024: Replacement of entire entry access system including gates, operators, replacement of columns and metal gates at a total cost of \$67,734.</p>

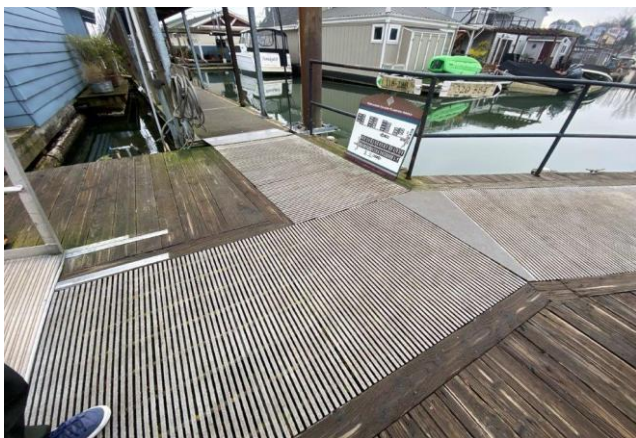
Landing-~Notes

**Comments:** The landing consists of a steel substructure and wood top boards, both of which are subject to environmental exposure from the Columbia River. To optimize long-term planning, these components are treated separately while maintaining a coordinated replacement schedule. The substructure is replaced every 40 years, with the top boards replaced at 20-year intervals—once at mid-life and again in alignment with the substructure replacement. This approach minimizes unnecessary material waste and ensures structural integrity. It is assumed that ongoing repairs and maintenance are addressed and paid for out of the operating budget.

Steel Substructure: Estimated 40-year lifespan, considering direct submersion and exposure to river conditions. Corrosion potential and environmental factors influence long-term durability.

Wood Top Boards: Estimated 20-year lifespan, with expected wear from moisture, foot traffic, and exposure. Decking is replaced once mid-cycle and again with the substructure.

2025: Wood top boards appear to be in fair condition, with a remaining useful life between 2 and 8 years.

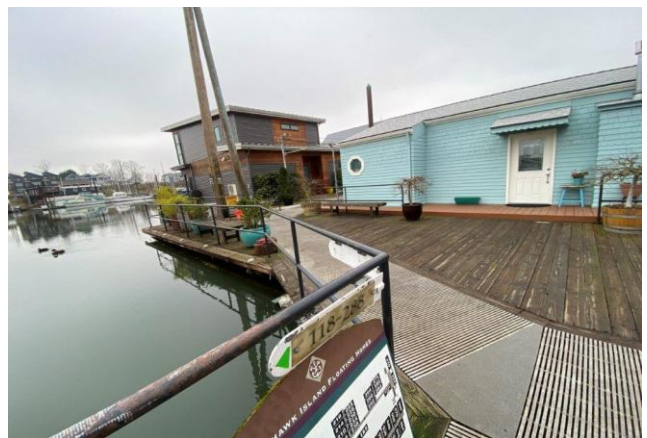
Landing-Pilings-Inspection

**Comments:** A qualified marine structural engineer or contractor specializing in waterfront infrastructure should perform periodic structural inspections of pilings to assess condition, identify potential corrosion, wood degradation, or other structural concerns. Unlike routine operating budget inspections, this assessment occurs every 10 years to detect hidden deterioration before failure, balancing proactive maintenance with cost-effectiveness. Inspections may involve underwater review, material integrity testing, or specialized equipment to evaluate structural condition

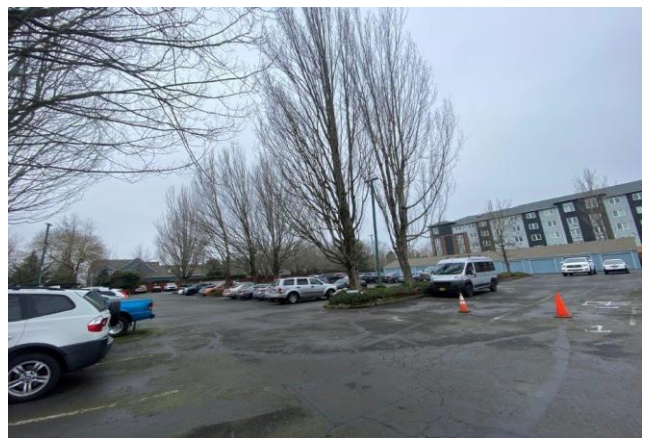
Parking Lot-Drain Pipe Maintenance

**Comments:** The drainpipe system was originally installed in 1982, and ongoing repairs have been necessary to address deterioration, blockages, and other maintenance concerns. Given the unpredictability of failures and past repair frequency, a budget-based approach is recommended, allocating funds periodically rather than assuming a single large-scale replacement.

Based on historical repairs, significant work has been required approximately every 5 to 6 years, with costs varying from \$4,463 to \$49,078, depending on the severity of the issues. The most recent major repair in 2024 cost \$49,078, indicating that future needs may fluctuate in scope and urgency.

To account for these variables, a \$15,000 budget should be allocated every 5 years to address routine maintenance, minor repairs, and unexpected failures. This interval aligns with the historical trend and ensures funding availability for necessary work.

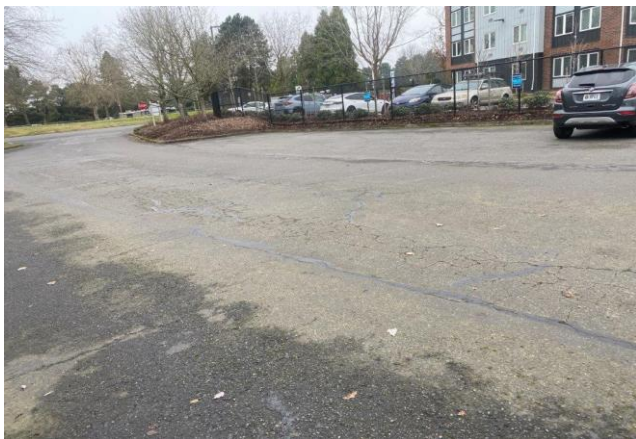
Paving-Asphalt-Repair, Crackseal,  
Sealcoat

**Comments:** Base year "Year Built" reflected is start of repair budget cycle.

Asphalt is a porous material that is deteriorated by water, dirt, oil and sunlight. To protect it from the elements, a sealcoating should be applied as paint is applied to siding. Sealcoating will seal against water, protect against UV rays which break it down, keep the asphalt from drying out and extend its useful life. It is highly recommended that two coats be applied to achieve the estimated useful life. Restriping (if applicable) included in the cost.

In general, it is recommended sealing asphalt surfaces within 2 years of their placement. This early treatment ensures that oils present in the surface asphaltic cement are protected from ultraviolet rays that harden the oils and cause surface rock to loosen from the asphalt.

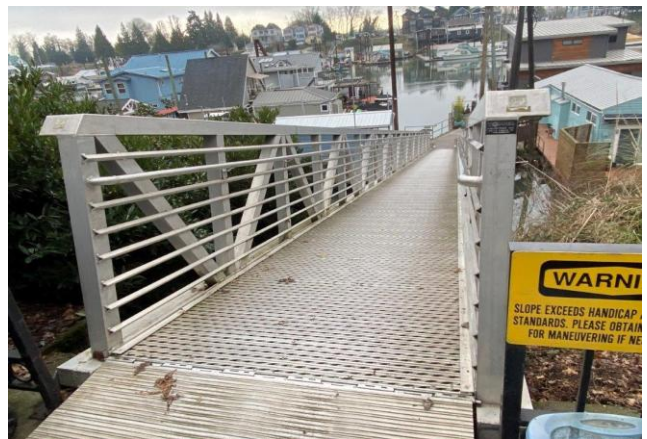
Ramp-Walkway-Aluminum

**Comments:** As an assumption, the aluminum pedestrian ramp is expected to last for ~50 years, with a built year of 2004. It appears to be in fair condition at the time of inspection, with no reports of major failures or repairs. We are assigning a 50-year life expectancy, so the ramp is due for replacement approximately 29 years from 2025. However, it is complicated to predict an exact failure year, as environmental factors and usage can impact its lifespan. Therefore, the condition of the ramp should be revisited annually, and the budget should be revised accordingly if conditions change. The cost for replacement, including utility disconnections/reconnections, handrails, and lighting, has been estimated at approximately ~\$80,000. This includes material costs for aluminum, handrails, and lighting, as well as labor for removal, installation, and utility work, factoring in the challenges of limited access. Utility reconnections for water, sewer, electrical, and telecom have been considered with additional costs for potential rerouting and specialized labor. Contingency costs have also been included to account for unforeseen issues during construction.

2025: Advise by Board that the year built is 1983 and measures 5x89 feet (445/sf). After meeting with Topper Industries, the original contractor, the Board was advised to increase useful life to 75 years. Information provided by contractor indicates that ramp meets ADA Guidelines more information can be found at (<https://www.access-board.gov/files/ada/guides/boating.pdf> see page 5.) The one exception noted is that the opening of the grates are a little large and there is its the potential for "high heel" accidents.

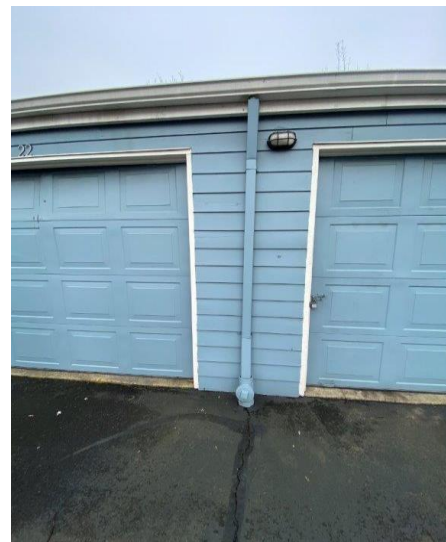
Item Description	# of Items	Unit	Current Item Cost	Future Replacement Cost	Year Built	Useful Life	Year Replace	Life Left	One Time?
Roof-Gutters & Downspouts	700	Ln.Ft.	\$ 10.00	\$ 9,650	2007	30	2037	13	Yes
<p><b>Comments:</b> Base year "Year Built" reflected is start of repair budget cycle.</p> <p>Gutters: 600 lf Downspouts: 100 lf 2025: Advised gutters are original.</p>									
Security System-Upgrade	1	Total	\$ 12,000.00	\$ 17,380	2024	15	2039	15	No
<p><b>Comments:</b> Future upgrades are anticipated within 8-15 years, focusing on equipment updates rather than full system replacement. Budgeting assumes upgrades to cameras, software, and access control components, with a projected cost of \$12,000 for the next cycle.</p> <p>2024: Work completed by Metro Overhead at a cost \$31,768</p>									
Sewage Ejection/Lift System-Pumps-Replace	2	Each	\$ 10,000.00	\$ 23,194	2019	11	2030	6	No
<p><b>Comments:</b> Pumps are replaced approximately every 15 years based on observed lifespan. Pump replacement cost is allocated separately from the full system replacement to account for different component longevity. Annual backflow certification (~\$160) is assumed to be handled through the operating budget.</p> <p>2009: Two pumps replaced for \$15,401 (~\$7,500/each) at 9 years old, indicating a shorter useful life.</p>

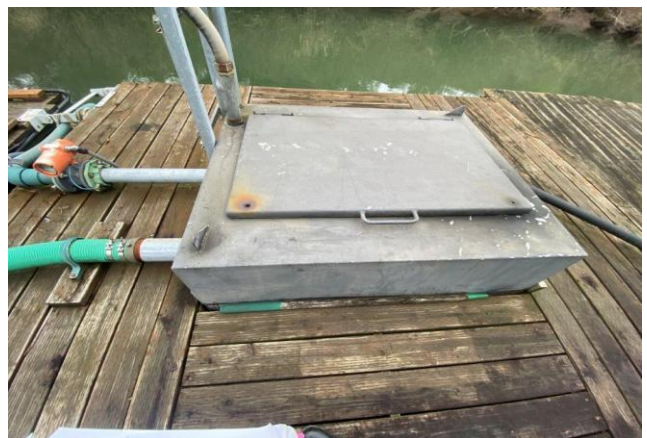
Sewage Ejection/Lift System-Replace	1	Total	\$ 50,000.00	\$ 57,985	2000	30	2030	6	No
<p><b>Comments:</b> Includes floats, controller, and 500-gallon holding tank (excluding pumps). Full system replacement planned every 25 years, aligning with industry standards for reliability. Pumps are accounted for as a separate component due to their shorter lifespan. Ongoing maintenance and minor cleaning are assumed to be handled through the operating budget.</p> <p>2000: Current lift system installed.</p>									
Shed-Replace	1	Total	\$ 5,500.00	\$ 7,216	2005	30	2035	11	No

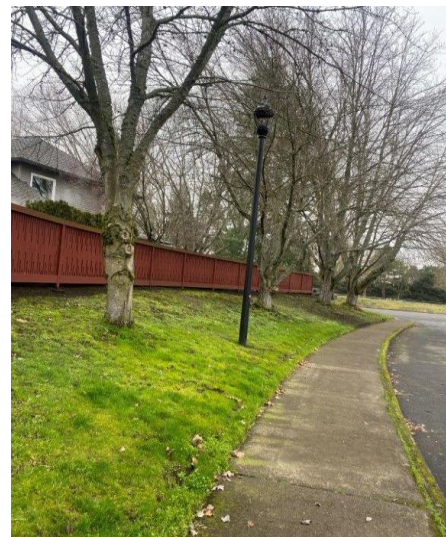
Treework	1	Total	\$ 5,000.00	\$ 5,657	2024	5	2029	5	No
<p><b>Comments:</b> Allocate funds for arborist inspections and corrective pruning to maintain tree limbs at least 6 feet away from buildings. Overhanging tree limbs can cause damage to roofs, decks, and other structures, reducing their useful life. They can also pose safety hazards, obstruct views, and interfere with utilities if left untended. Utilize this budget over a 5-year period for necessary pruning and maintenance. Document the year, work performed, and associated costs. Adjust the next cycle's budget based on the arborist's recommendations to ensure the health of the trees and the safety and longevity of the community's infrastructure. 2025: Treework has occurred nearly annually over the last decade, Board has advised that the main concern is pruning for the trees in the parking lot to prevent ice storm damage.</p>
