# 2025 Reserve Study & Maintenance Plan

## Tomahawk Destiny

Portland, OR

March 19, 2025

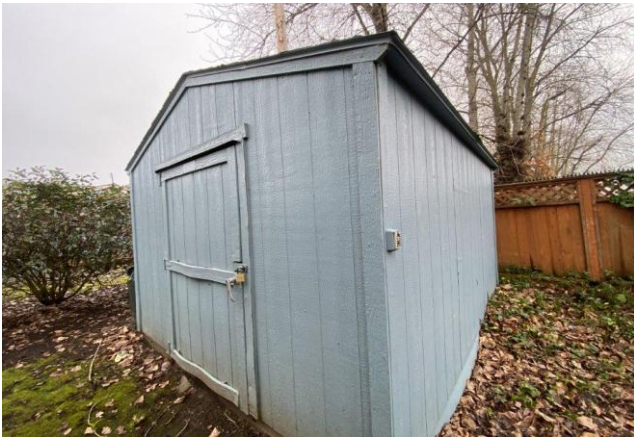
Sewage Ejection/Lift System-Replace	1	Total	\$ 50,000.00	\$ 57,985	2000	30	2030	6	No
<p><b>Comments:</b> Includes floats, controller, and 500-gallon holding tank (excluding pumps). Full system replacement planned every 25 years, aligning with industry standards for reliability. Pumps are accounted for as a separate component due to their shorter lifespan. Ongoing maintenance and minor cleaning are assumed to be handled through the operating budget.</p> <p>2000: Current lift system installed.</p>									
Shed-Replace	1	Total	\$ 5,500.00	\$ 7,216	2005	30	2035	11	No

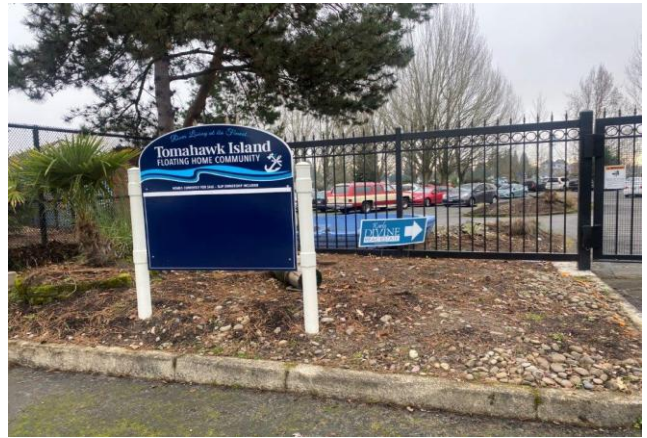
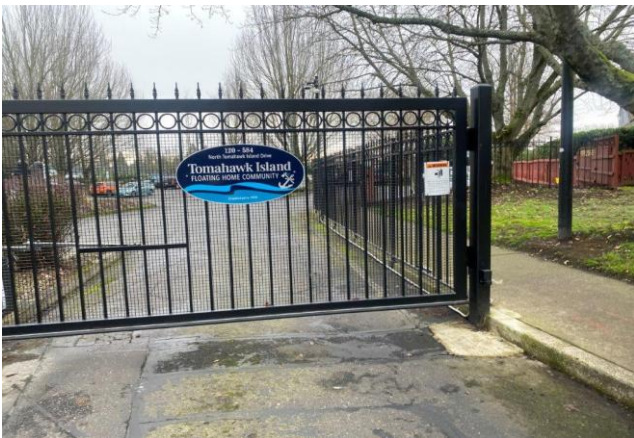
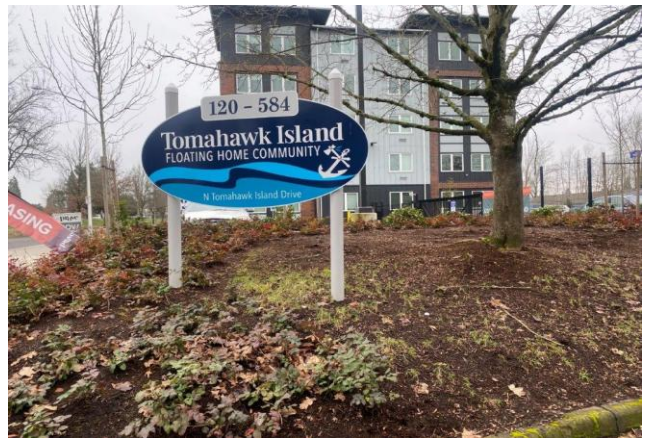
Item Description	# of Items	Unit	Current Item Cost	Future Replacement Cost	Year Built	Useful Life	Year Replace	Life Left	One Time?
Signs-Entry & Other	3	Each	\$ 1,000.00	\$ 5,562	2024	25	2049	25	No
<p><b>Comments:</b> The three monument entry signs are constructed of a composite material designed for durability. The budget includes full replacement of the signs, including panels, structural supports, lettering, and any necessary permitting. No lighting is assumed. A 25-year useful life is assigned, with refinishing or minor repairs expected to be handled through routine maintenance.</p> <p>The gate sign (1 total) and parking signs (6 total) are minor expenses and will be replaced as needed under the operating budget, as costs are minimal and do not warrant long-term capital planning.</p>									
Trash Enclosure	75	Ln.Ft.	\$ 60.00	\$ 4,846	2007	20	2027	3	No
<p><b>Comments:</b> Base year "Year Built" reflected is start of repair budget cycle. 2025: Advised by board Trash Enclosure is was original installed in 1985 and nearing the end of it's useful life.</p>
